OR99E: MP 20.35 – SW BERG PKWY (CANBY)

SCOPE OF WORK

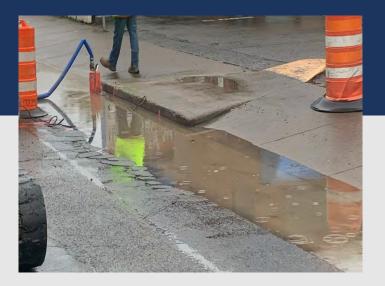
Water ponding along mainline

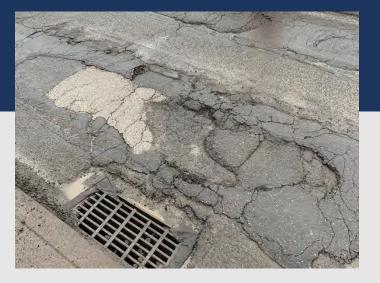
- Remove and Replace existing Storm Sewer
 - Cause of failing road 60-year-old unreinforced concrete pipe
 - Highway would not hold up another year
- Contract Time
 - Contract Suspended for 6 months
 - 365 Days Added

Road failing over existing storm sewer

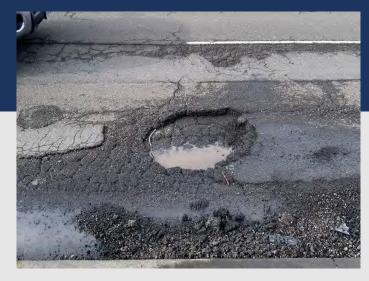
Deep potholes forming

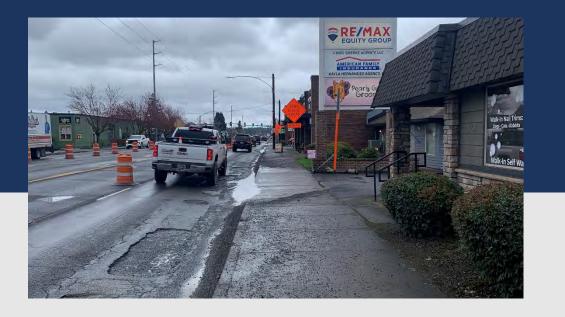
Prior to Repair Lanes in Extremely Poor Repair
