Emergency Project: Necarney Creek Bridge Repair US-101 Manzanita

Calvin Marvich, ODOT - Construction Specialist Region 2

Tim Whiteis, Wildish - Project Manager

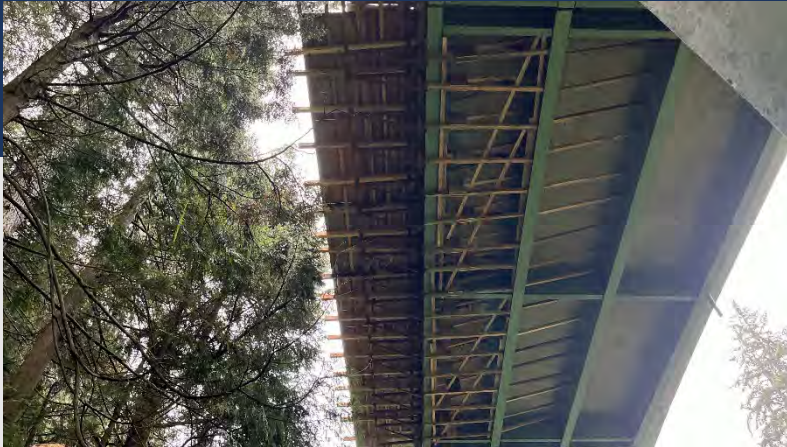
Falsework installed

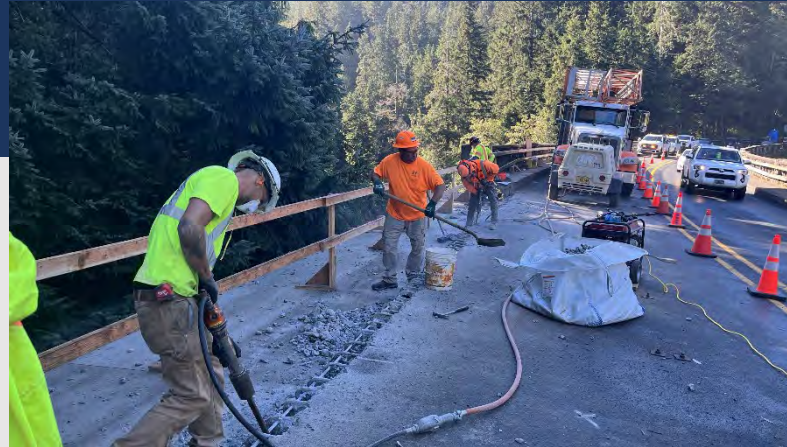
Chipping guns used to remove concrete
