OR99E: MP 20.35 – SW BERG PKWY (CANBY)

SCOPE OF WORK

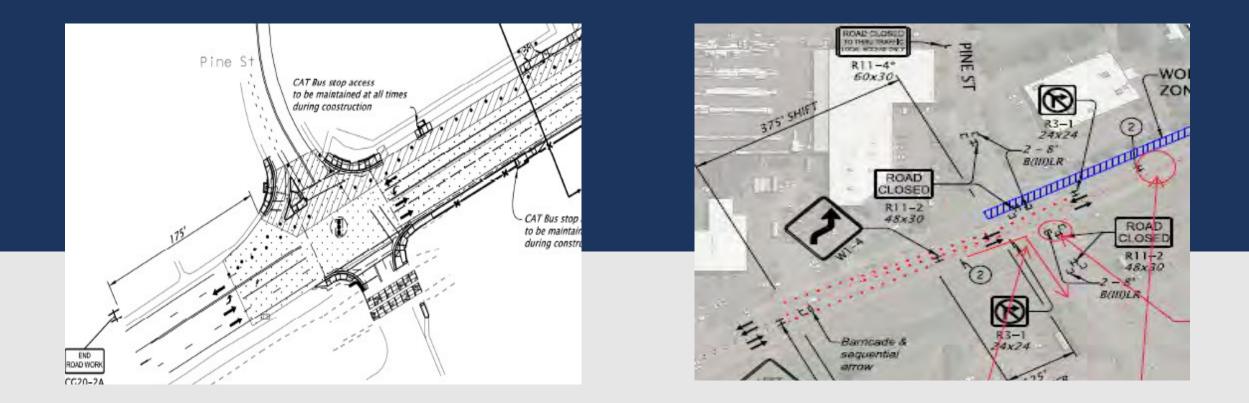
Original Traffic Control Plan

K&E Provided Traffic Control Plan

- Contractor Provided/ODOT Approved Traffic Control Plans
- Crossovers with Signal Shutoff
 RR Notification and Testing
- Allowed Multiple Work Areas
- 4773 tons ACP saved
- Increased Work Zone Safety

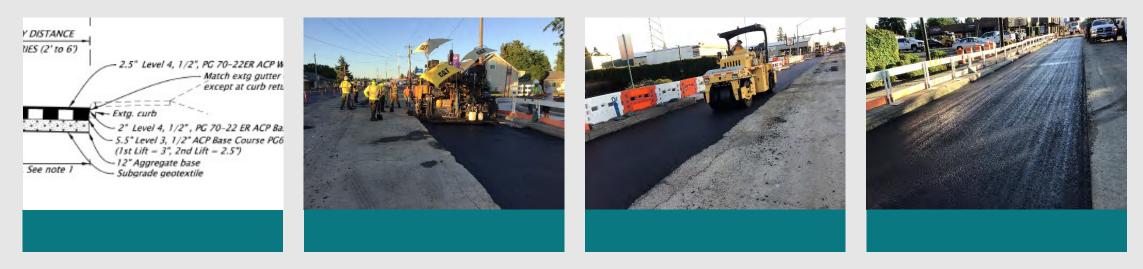
5.5" Deep Base Lift

Plan Cross Section

Confined Area

Pneumatic Roller used Base allowed to cool overnight

- Must be a Fully Contained Area
- Must be Base Course
- Pneumatic Roller used for full depth compaction
- Core Correlation taken
- 10 Additional Cores taken and cut into 3 equal parts for Density Verification throughout mat
 - Top 95.8%, Middle 97.3%, Bottom 96.2%
